# Multibeam Acoustic survey of the EPA-Designated Ocean Dredged Material Disposal Site (LA-5) Located Offshore of San Diego, California

# **Report of Survey**

December 20th 2018

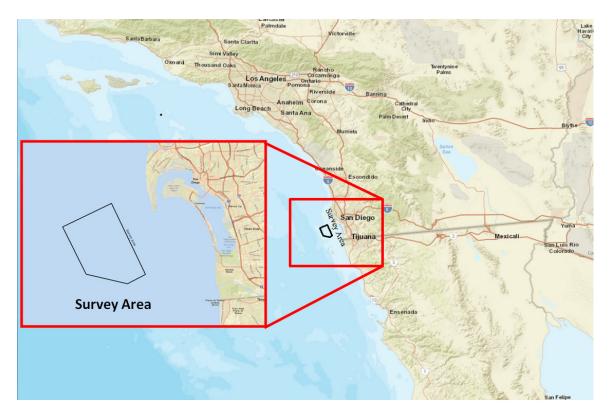
Figure 1 Survey area location

This report is prepared for Battelle (Battelle) by eTrac Inc (eTrac) as part of the deliverables for the 18-567 Multibeam Acoustic survey of the EPA-Designated Ocean Dredged Material Disposal Site (ODMDS) LA-5 Located Offshore of San Diego, California, EPA WA4-09 - LA-5 ODMD Site Monitoring Survey. Figure 1 shows the project area. The survey area was designated by Battelle as detailed within the RFP 18-567. Coverage was obtained up to the border offshore and then along shore as close as possible where maintaining safe survey conditions.

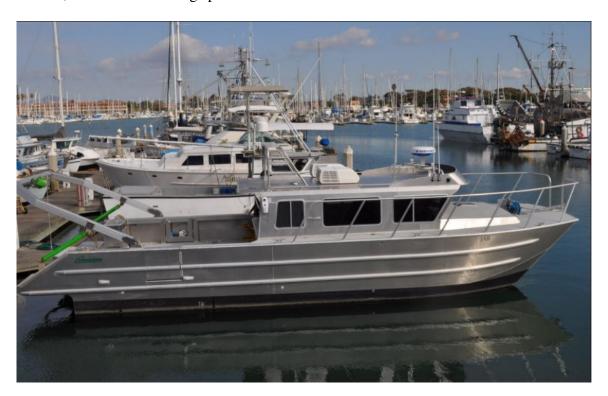
Figure 2 Starboard side view of the M/V JAB

All work was completed onboard survey vessel *M/V Jab*. The JAB is a 44' Armstrong Marine Jet Powered Aluminum Catamaran that drafts 2.5 ft. The Vessel is equipped with a shock mounted computer rack, moonpool multibeam mount, antenna mounts, monitor mounts, dedicated mounting space for an IMU.

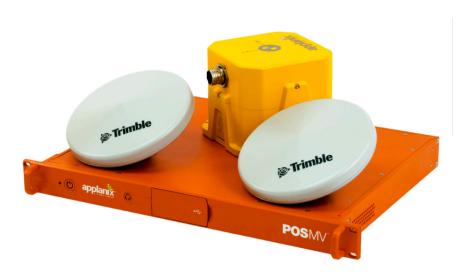
Figure 3 Applanix POS MV Oceanmaster

A highly accurate, inertial motion and positioning system was used for vessel positioning. The system, an Applanix POS MV V4 Oceanmaster is an integrated position and motion system. It measures all vessel movement including heading and integrates accurate position and timing to provide an entire solution of the position of ay sensor on board the vessel. The system was upgraded in 2017 to contain the same hardware as a V5 system within the operating CPU. The system has an integrated, internal WAAS, DGPS system which was used for online acquisition. All vessel position and motion data was logged so that a highly accurate (~3cms) post processed kinematic position solution could be applied to the sensor data.

- Position Accuracies PPK: Horizontal: +/- (8 mm + 1 ppm x baseline length)3 Vertical: +/- (15 mm + 1 ppm x baseline length)
- Motion Accuracies, Roll and Pitch: 0.015° in PPK
- Heading Accuracies: 0.03° (2 m baseline)
- Real time Heave 5cms and Trueheave Solutions available increasing to 3cms
- With POSPac Processing allows PPK solution with GLONASS AND GPS satellites.

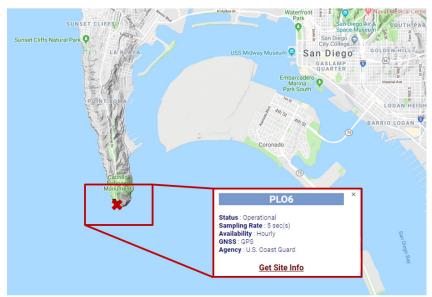
Figure 4 Location of PLO6 CORS Station

A Continuously Operation Reference Station (CORS) GPS was used for the Post Processing of the Realtime data for an SBET solution. The CORS station used was PLO6, which is located near Point Loma as seen in Figure 4.PLO6 is a 5 second station operated and managed by the US Coast Guard. The PLO6 CORS station has been used on various occasions by eTrac Inc therefore confirming its reliability through repeated uses throughout the San Diego Bay Region. Every 24hrs a base file is available for download from the station.

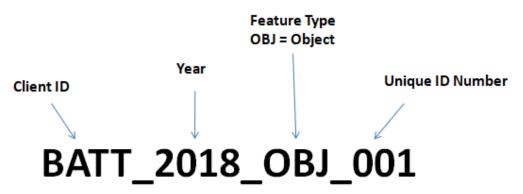
Figure 7 Geodatabase Unique IDs

A geodatabase was made to store all the findings. These are referenced by year and type of object or cable found in order that if there are any further developments change can be noted. Each feature is given a unique id code Figure 7 Geodatabase Unique IDs.

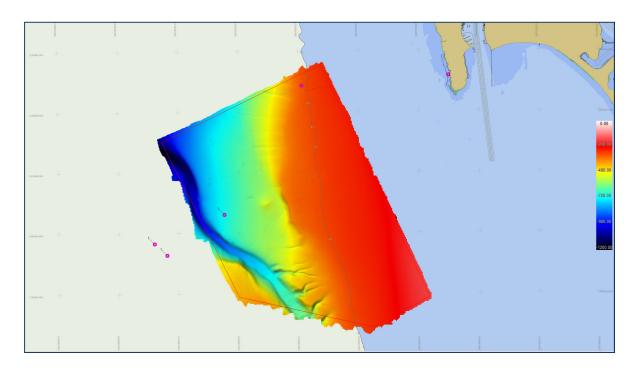
Figure 8 Overview of complete Multibeam coverage

120% multibeam coverage was achieved in entire survey area. All the position data was successfully post processed so that up to 100% of the data was post processed kinematic where accuracies of 0.1ft were achieved.

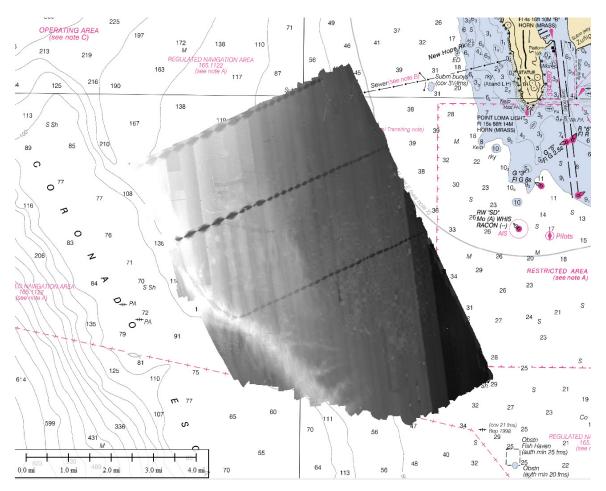
Figure 9 Overview of complete MBES backscatter

Complete Bathymetric coverage is shown in Figure 9. The overview is relief shaded from the observable depth ranges of 170ft to 1200ft MLLW. Derived from the imagery is a subsea canyon, as well as the LA-5 Disposal site and an outfall pipe.

Figure 9 is an overview of the backscatter derived from the Multibeam survey. The most obvious feature seen is that of the subsea canyon. Other notable segments are the small streaks and circular features that occur throughout the survey area.

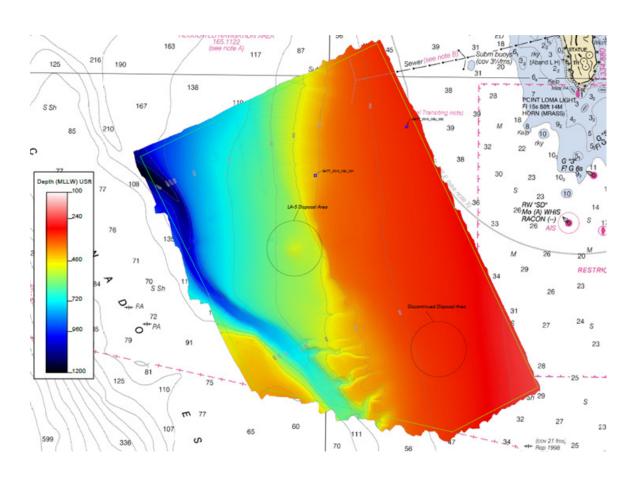
Figure 10 Overview including LA-5 Disposal Site and deactivate disposal site

The LA-5 Disposal site was observed being 90ft high in about 500 to 610ft of water depth. The disposal site had no apparent difference in sediment form it's surrounding as analyzed from the backscatter data. The overview can be seen in Figure 14 and a close up is found in Figure 15.

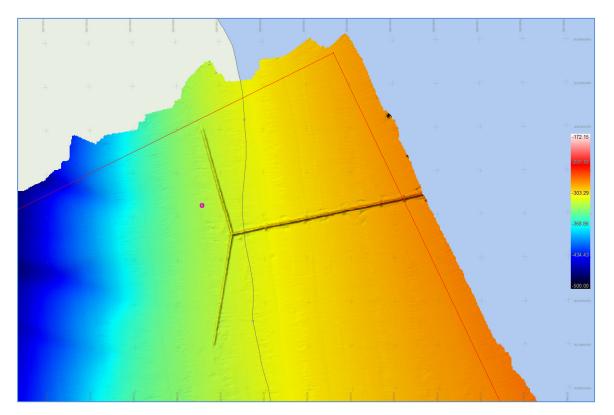
Figure 12 Overview of the outfall pipe

The Outfall pipe was clearly seen in the Multibeam data in depths of 300ft. There was no obvious change in the sediment types near the outfall pipe (backscatter analysis). This can be seen in Figure 16.

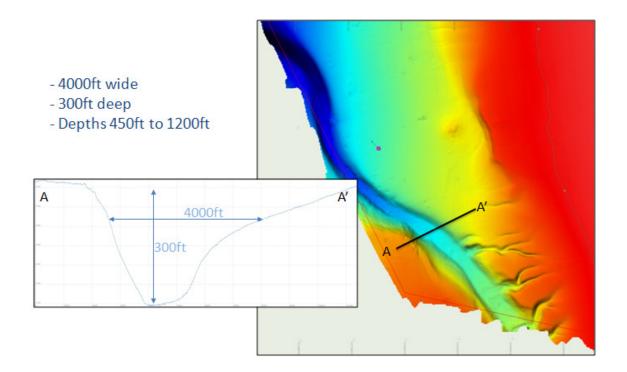
Figure 13 Analysis of a subsea trench in the survey area

In Figure 17 a Subsea Canyon was identified. The dimensions of the observable portions of the canyon were 4000ft wide and about 300ft deep. The canyon was surveyed in the depths of 450ft to 1200ft.

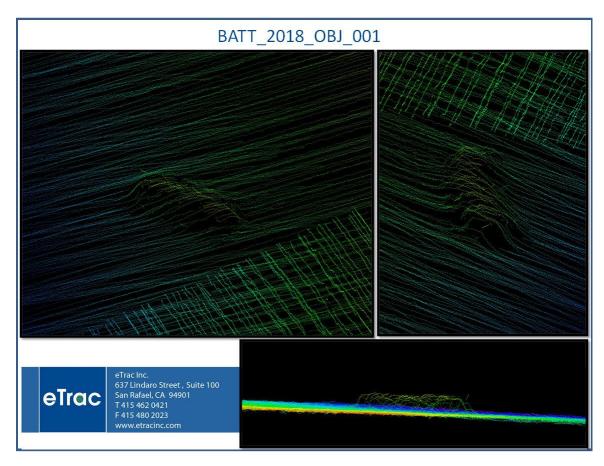
Figure 14 An object (OBJ 001) can be seen in the MBES data

The first object found, OBJ 001, was discovered about 1.5ft North East of the disposal site. The objects dimensions were 164'x100'x9'ft, and it was rectangular. From Figure 10 and Figure 11 you can see that is largely inconclusive what the object is.

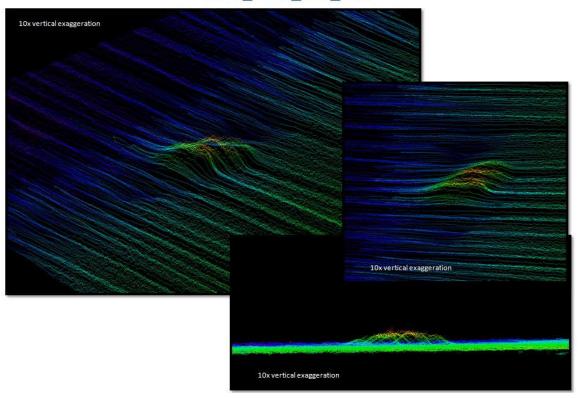
Figure 16 The second object (OBJ 002) can be seen in the MBES data

The second object, OBJ 002, was discovered a greater distance from the disposal site, approximately 3.5miles North East. The object measured 191'x94'x3'ft in a rectangular pattern. Figure 12 and Figure 13 show OBJ 002, though its identity is also largely inconclusive.

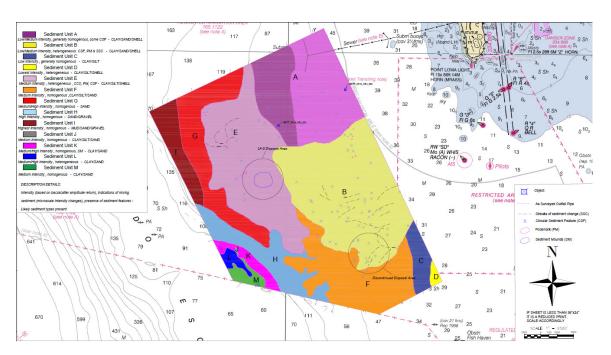
Figure 18 Overview of sediment analysis from backscatter

The backscatter data provided enough information to distinguish between 13 sediment units. An estimation of the sediment types was made based on the backscatter return as well as details from NOAA sampling job H08979 and 297Velero. The dotted lines are streaks of sediment change.

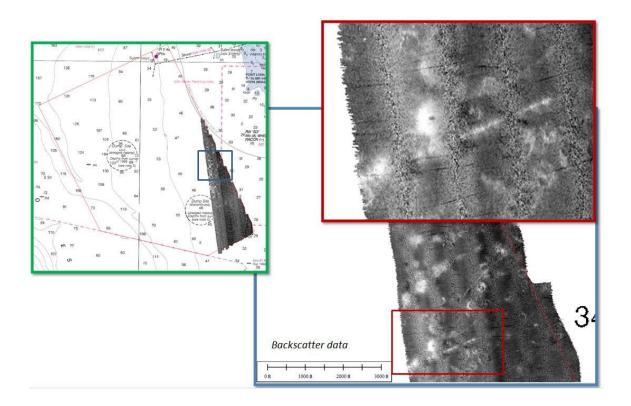
Figure 19 Surface sediment changes in backscatter resulting in streaks

Several areas of surface sediment changes were discovered in the backscatter data. These changes were not evident within the bathymetric data as they had no relief changes. There were 1500ft to 2500ft long and upwards of 40ft wide.

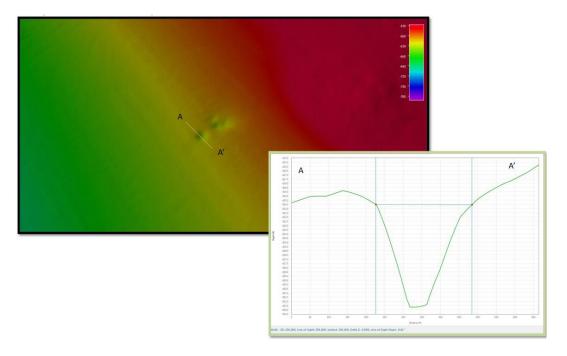
Figure 20 Evidence of pockmarks

Figure 19 shows apparent signs of pockmarks that were visible in the bathymetric data. There were upwards of 20 individual pockmarks noted. These pockmarks were up to 15ft deep and 150ft in diameter.

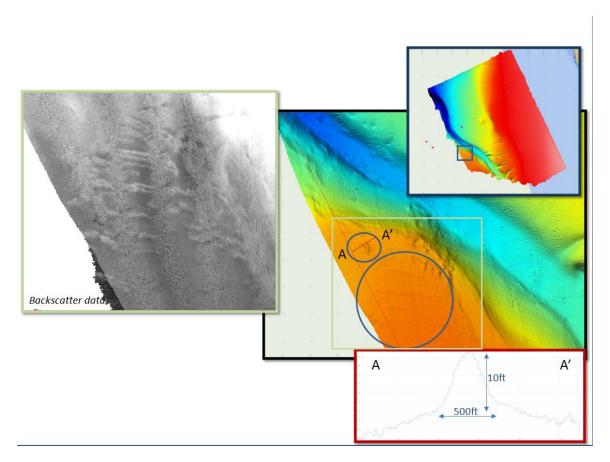
Figure 21 Large irregular sediment mounds

Another notable sediment feature was the section of mounds seen in Figure 21. These mounds were irregularly shaped and were evident in both the bathymetry and backscatter datasets. At their largest there were up to 10ft high and 500ft wide.

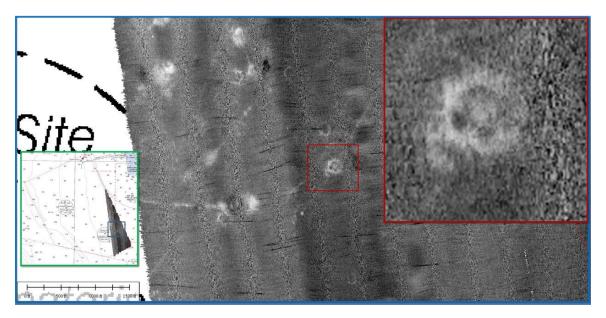
Figure 22 Surface sediment changes in backscatter resulting in circular features

The final sediment change of significance was not visible in the bathymetry, but once again, clearly distinguishable in the backscatter. Therefore it can be ascertained that this is a surface sediment change. These circular patterns were 350ft in diameter and over 50 were noted in the area. They were most notable in the areas of sandy silt.

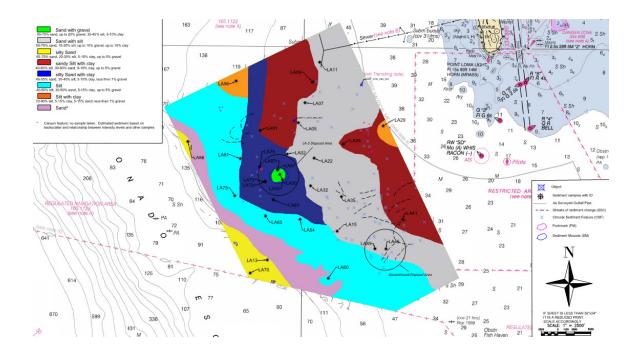
Figure 23 Updated sediment map from ground sampling

After the Multibeam survey collection and processing efforts of eTrac, Battelle/EPA collected various bottom samples throughout the Survey Area. The map in Figure 23 is a sediment map based on the various ground samples collected. Grain size results were grouped using percentage cut offs based on the ASTM\_D\_2487 sampling groups. The sediment classification and related grain size percentage is shown below in Table 1.
